A FLOOD PLAIN MANAGEMENT STUDY

For the Town of
Thetford, Vermont

FLOOD PLAIN MANAGEMENT STUDY
TOWN OF THETFORD
ORANGE COUNTY, VERMONT

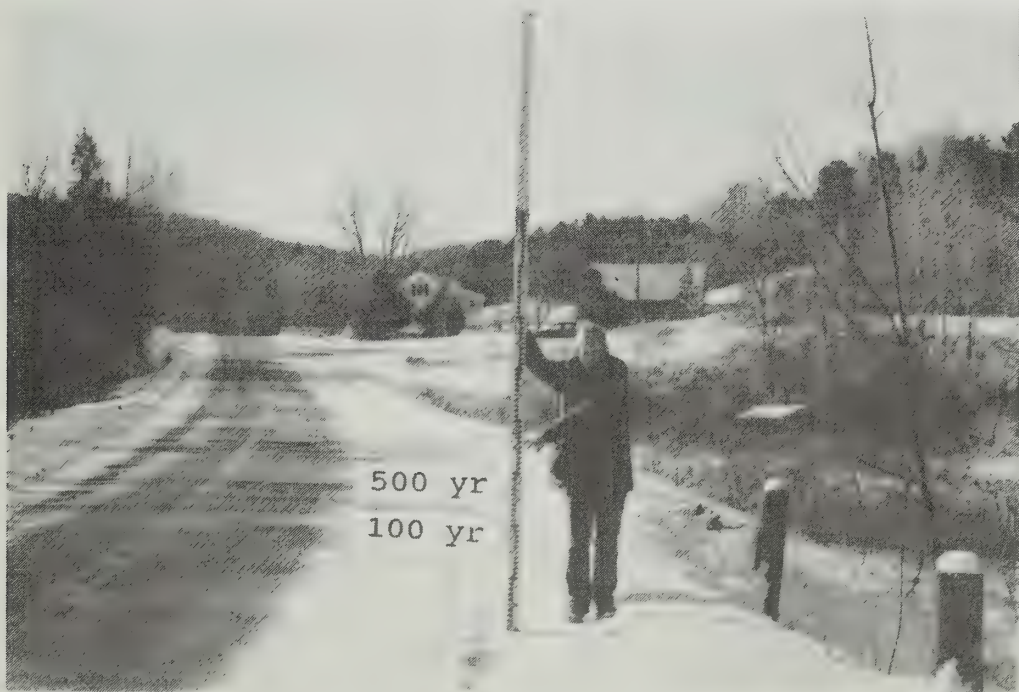
Figure 2. On Rt. 132 at Abbott Brook crossing

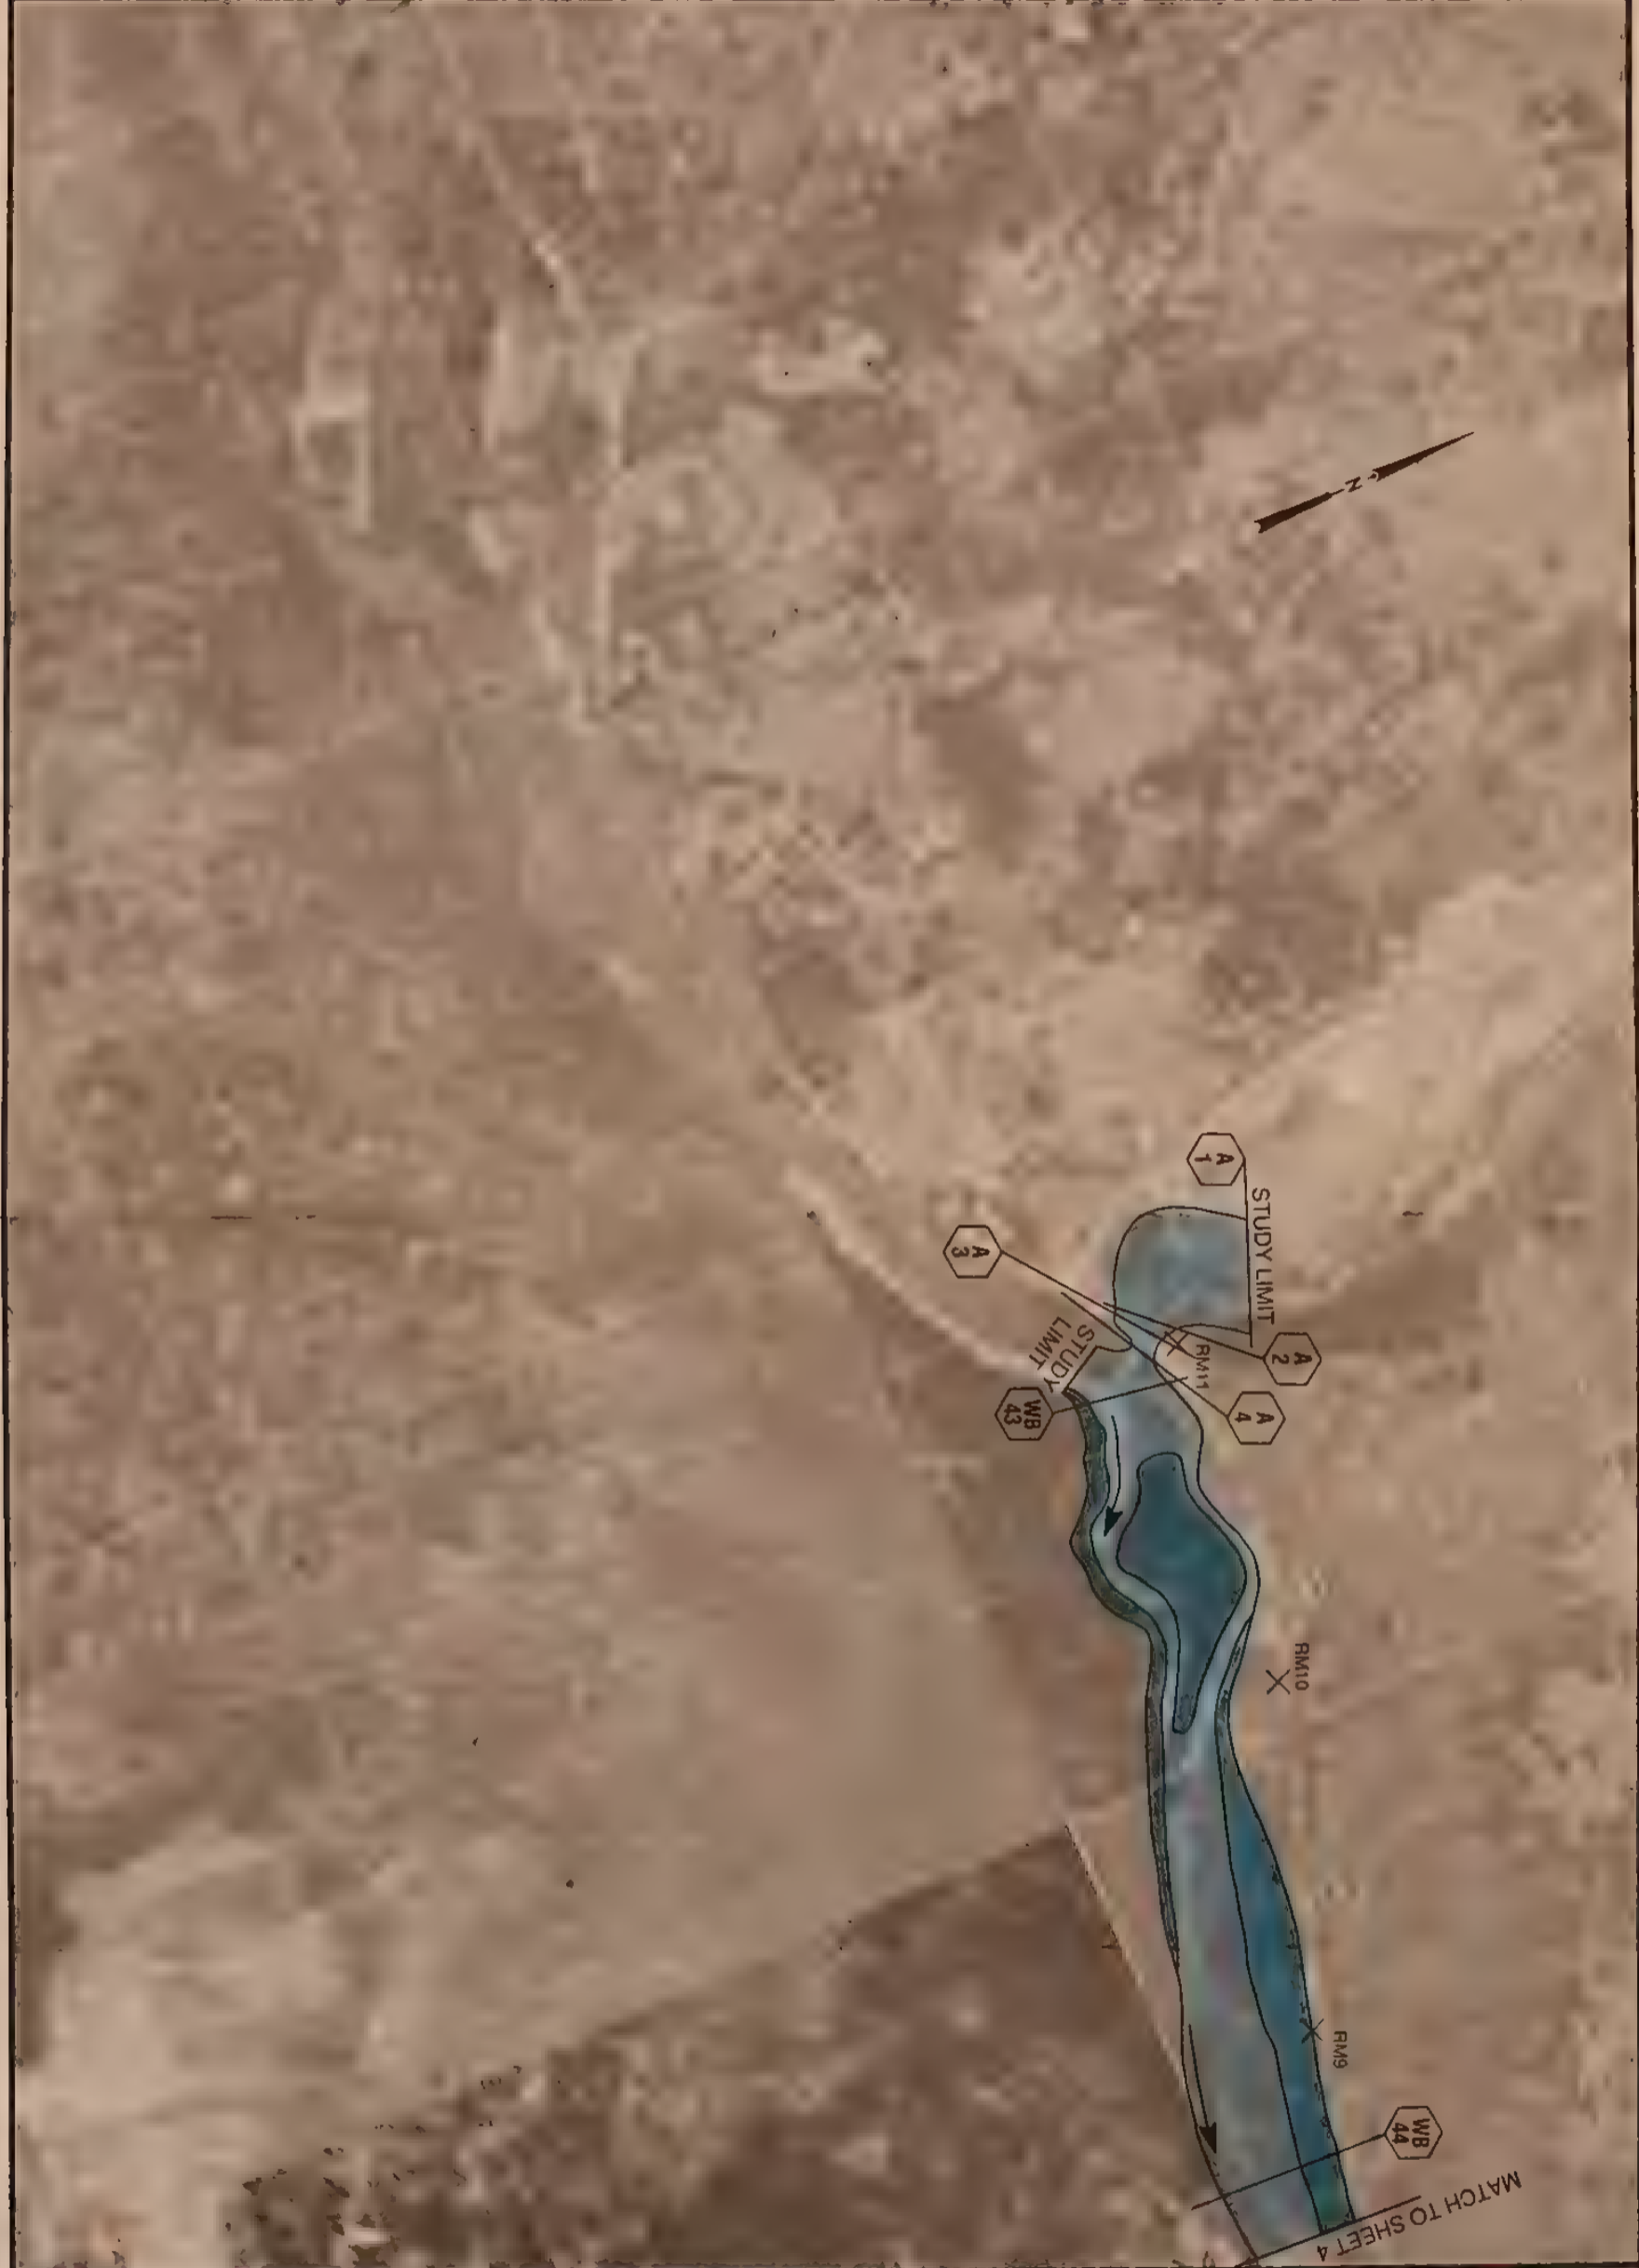
FLOOD HAZARD AREA
WEST BRANCH OMPOMANOOSUC RIVER

LEGEND
 100 YEAR FLOOD AREA
 500 YEAR FLOOD AREA
 SURVEYED CROSS SECTION

The photomaps entitled "Flood Hazard Areas" (sheets 1 through 5 in Appendix A) show the 100-year and 500-year flood areas. These areas are depicted based on present land use and management conditions. The flood boundaries show the approximate location on the ground for general reference purposes. The 500-year flood boundary is to be interpreted as being close to the 100-year flood boundary where it is not separately mapped. The reason for this is that the valley side slopes along many reaches of stream are steep and the map scale small. This yields a 500-year boundary which is nearly contiguous with the 100-year boundary. Along such reaches it is therefore not mapped.
